Brief information about the find

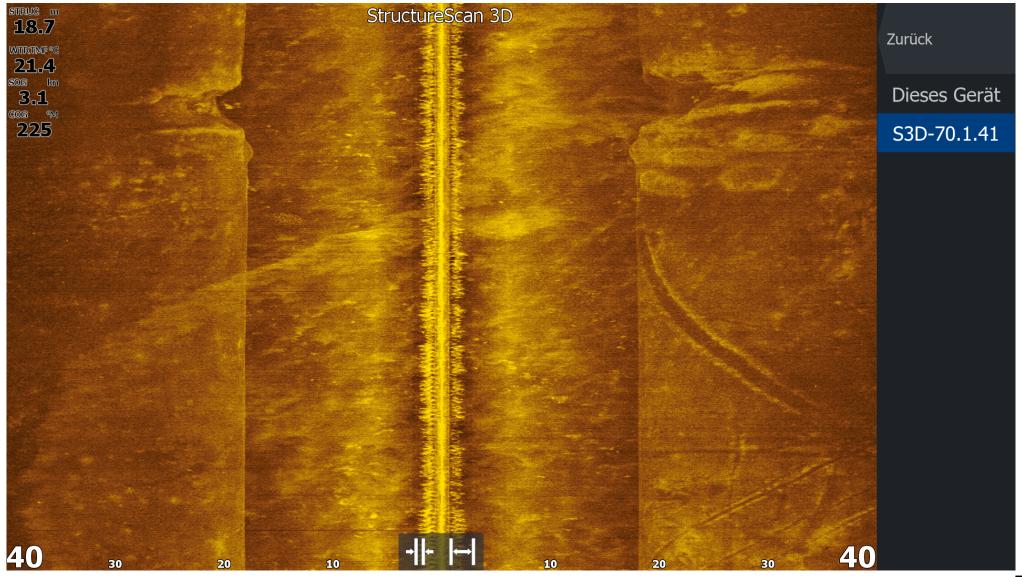
During the exploration of the bottom of the southern inner fjord, the observations shown in the figures were made at the position 54°50.0752'N and 009°28.3491'E.

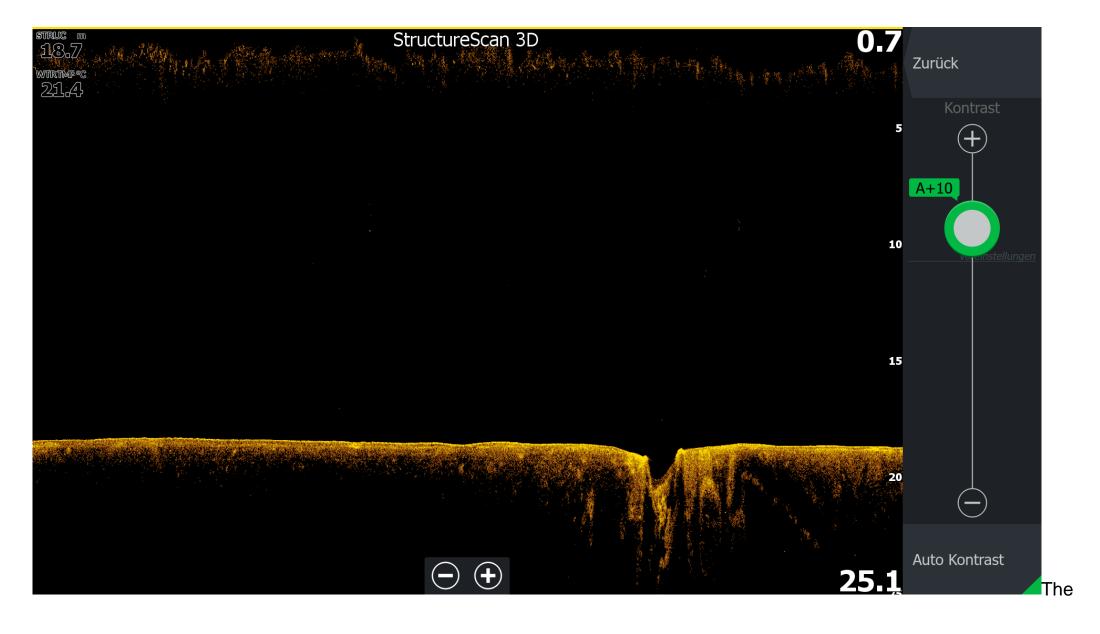
side-scan image shows an approximately 60 m long depression on the bottom in the upper part of the image. This depression is up to 10 m wide.

These observations provide evidence of the sinking site of a German submarine, presumably a Type 7 (C?). This submarine type was the most common in the Kriegsmarine during World War II. The remains of a submarine of this type were located south of the Ochseninseln last year. These boats were scuttled on May 5, 1945, to escape Allied control (Operation Regenbogen). However, the sunken submarines, which possessed considerable material value, were raised in the postwar years. When it was not possible to salvage them in their entirety, the wrecks were blown up and recovered in pieces. However, the extent to which the current find actually represents the sinking site of a submarine remains uncertain. A possible find must therefore still be confirmed through diving. The site lies between 16 and 18 meters deep. The bottom is assumed to be very muddy.
