# Location U-Boat 2

## **Brief information about the find**

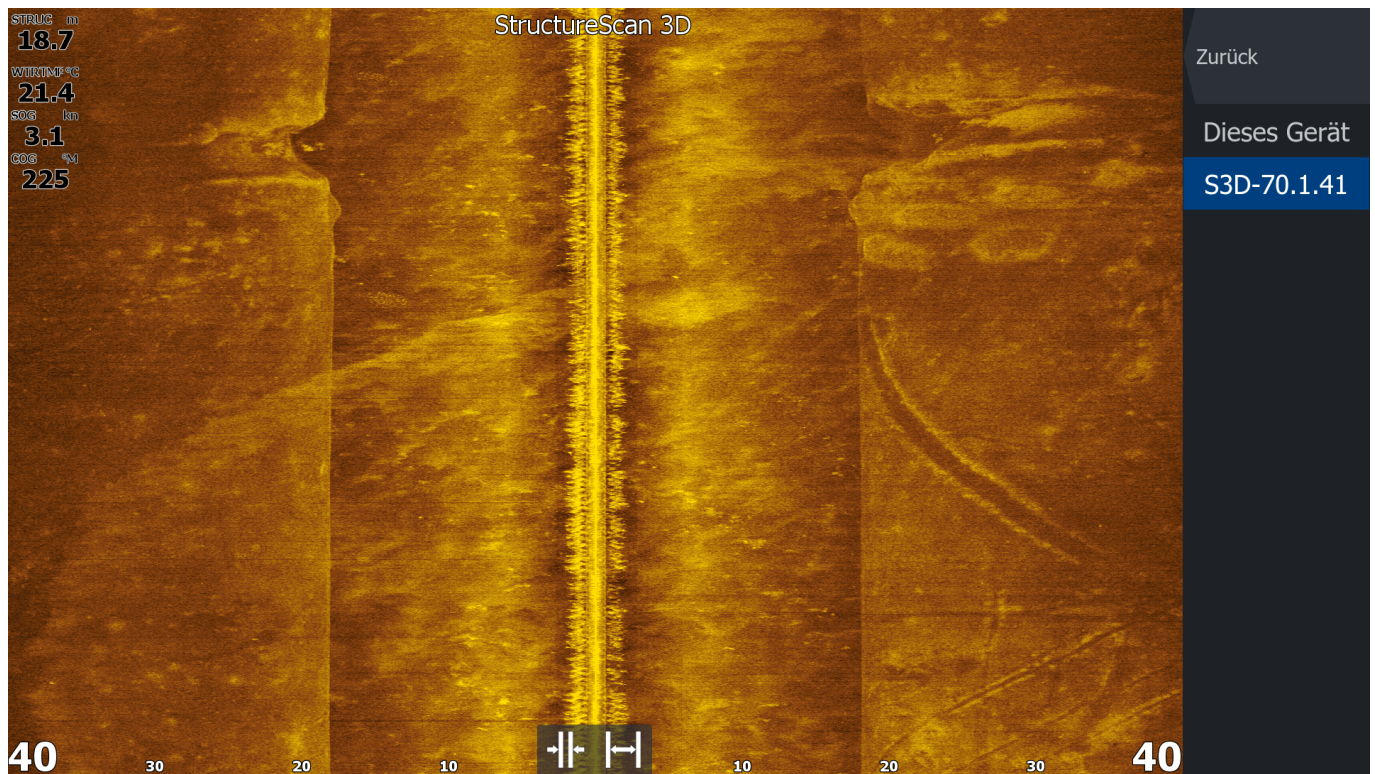
The side-scan image shows an approximately 60 m long depression on the bottom in the upper part of the image. This depression is up to 10 m wide.

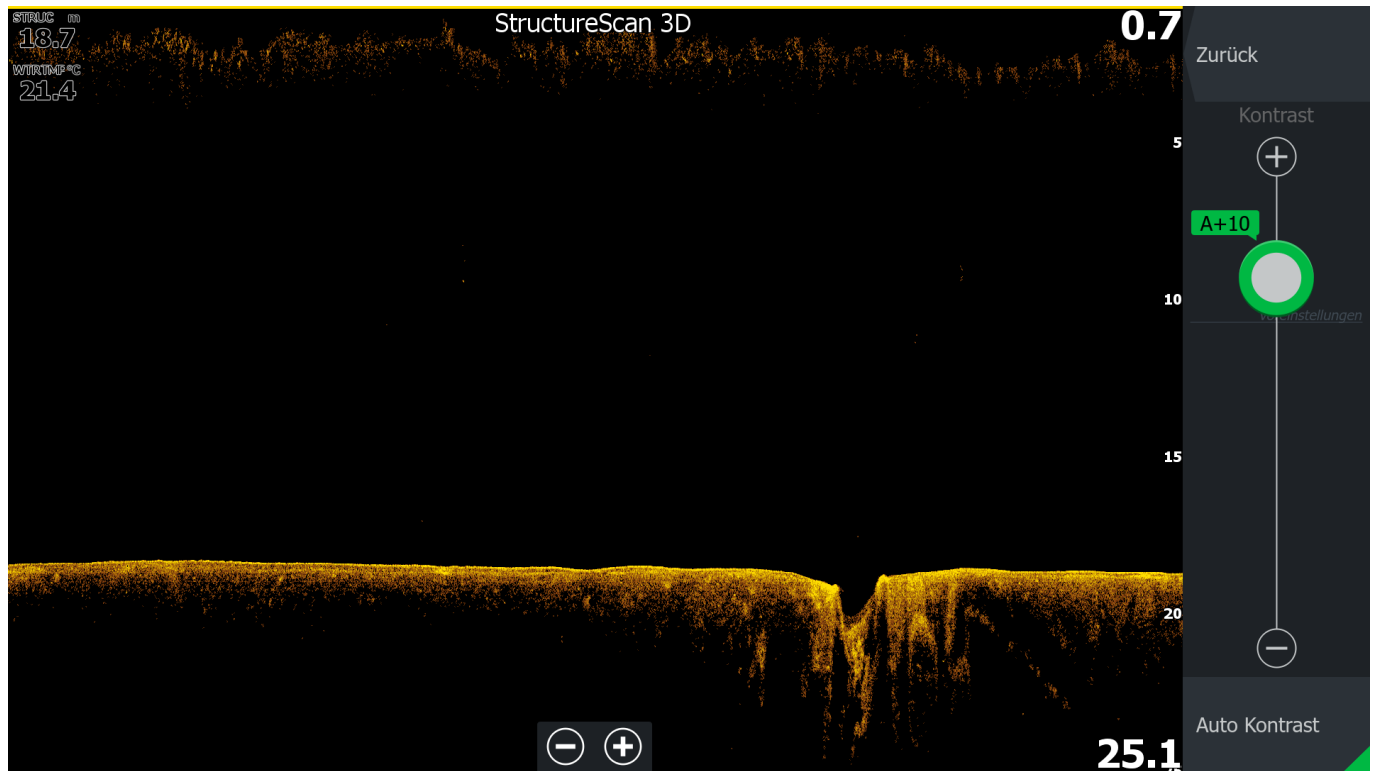
The down-scan image underlines this finding.

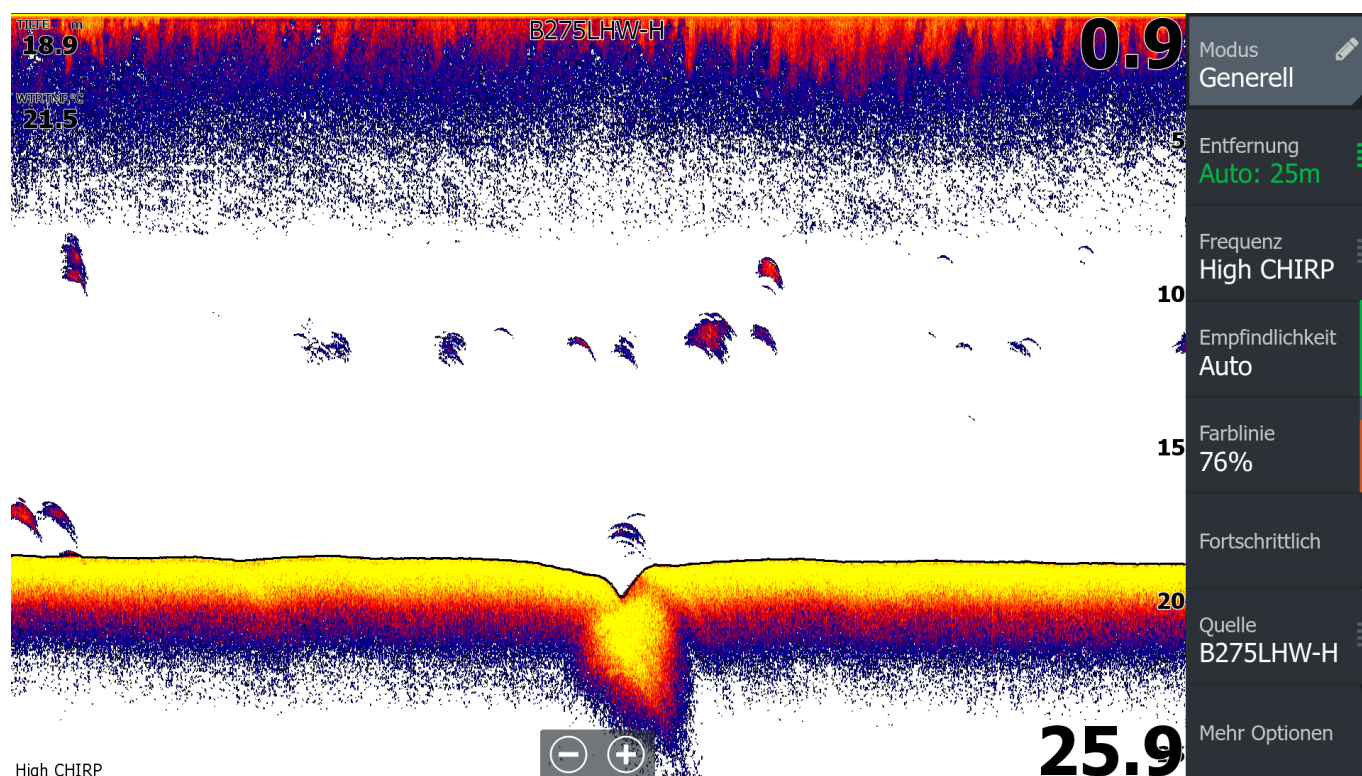
The echogram is interesting. It is the most informative for measuring the find. It shows the depression mark, which extends approximately 1.2 meters into the surrounding ground at the measured location.

The loose sediment (mud and biogenic precipitation) is pressed deep into the ground here.

These observations provide evidence of the sinking site of a German submarine, presumably a Type 7 (C?). This submarine type was the most common in the Kriegsmarine during World War II. The remains of a submarine of this type were located south of the Ochseninseln last year. These boats were scuttled on May 5, 1945, to escape Allied control (Operation Regenbogen). However, the sunken submarines, which possessed considerable material value, were raised in the postwar years. When it was not possible to salvage them in their entirety, the wrecks were blown up and recovered in pieces. However, the extent to which the current find actually represents the sinking site of a submarine remains
